New York State Department of Transportation

Yellow Flag NB2358W003

BIN: 1065318

Location: Span 23, Girder G11 at Pier 23 above the left lane of 65th Street EB roadway between 4th and 5th Avenue.

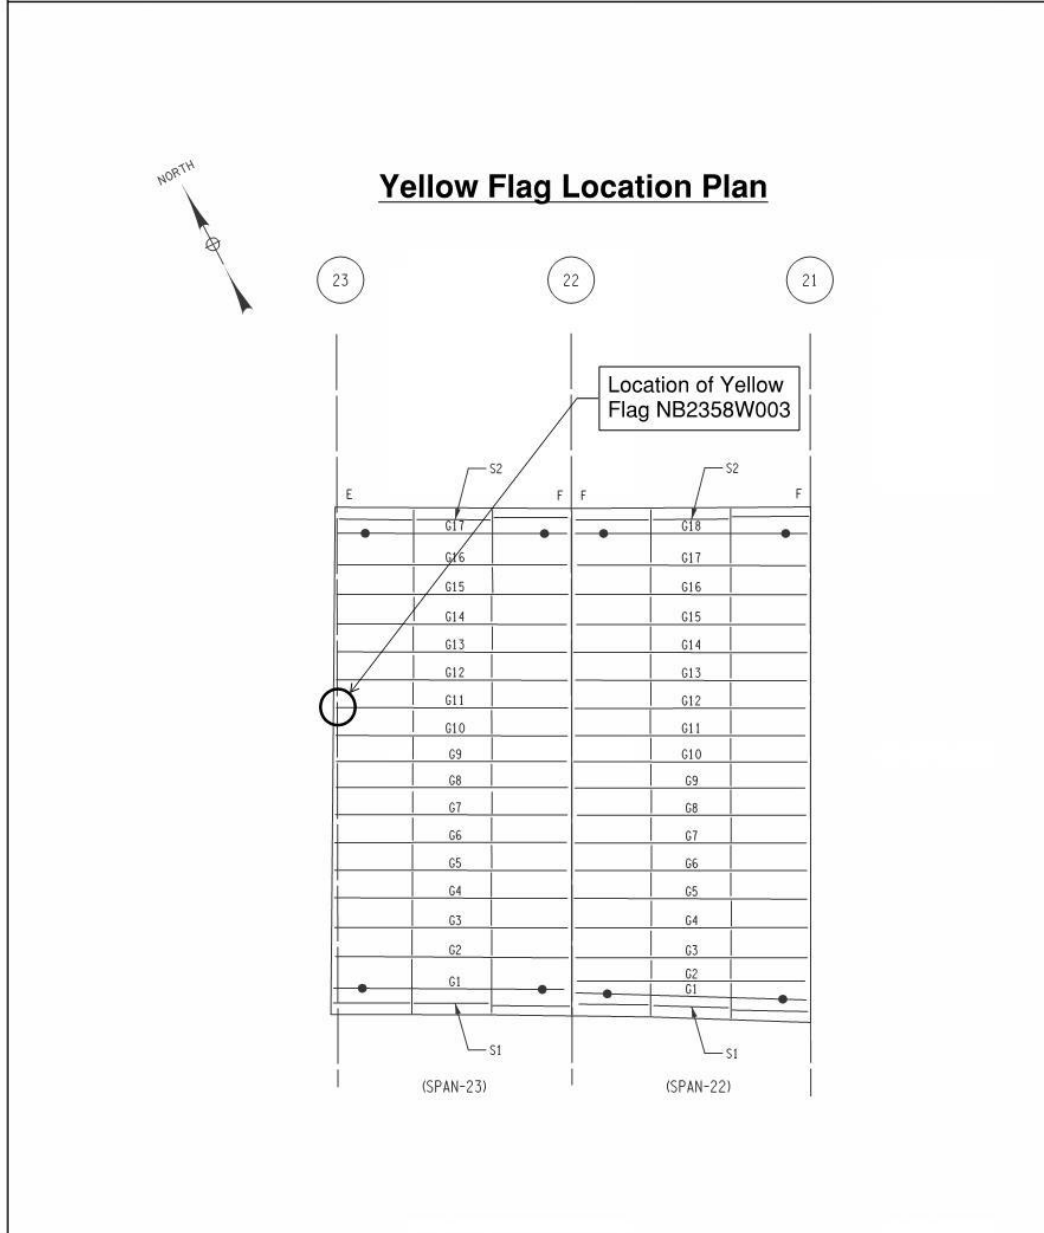
Flag PhotographsPhoto Number: **1**Photo Filename: **23_Flag Location Plan.jpg**Gowanus Expressway
2023 Biennial Inspection - Field SketchBIN: 1065318Team: AA/TSDate: 04/14/2023Span: 23Location: Girder G11 at Pier 23

**wsp****Attachment Description: Flag Location Plan**

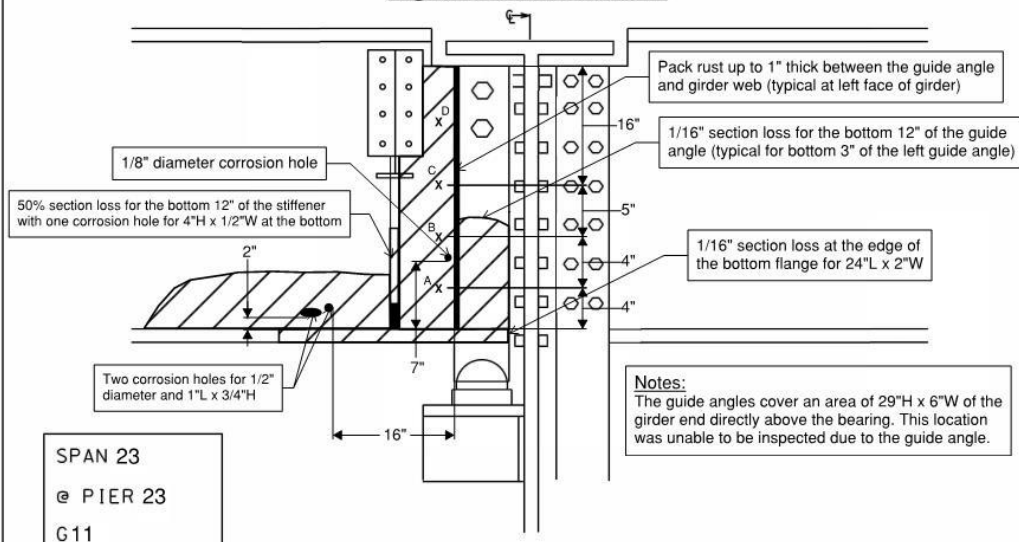
Photo Number: 2

Right Face of Girder G11

Point	D-Meter Readings (in)	Calculated Section Loss (%)
A	0.23	67%
B	0.32	53%
C	0.55	20%
D	0.57	17%

Remaining shear web area = $(0.23 \times 4) + (0.32 \times 4) + (0.55 \times 5) + (0.57 \times 16) = 14.07 \text{ in}^2$ As-built shear web area = $0.6875 \times 29 = 19.94 \text{ in}^2$ Overall shear web area section loss = $(19.94 \text{ in}^2 - 14.07 \text{ in}^2) / 19.94 \text{ in}^2 = 30\%$ Average localized section loss adjacent to bearing = $(0.6875 - [(0.23 + 0.32) / 2]) / 0.6875 = 60\%$

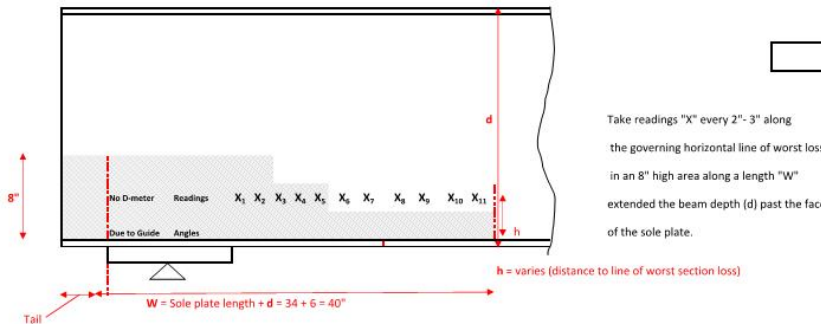
Photo Number: 3

GIRDER LOWER WEB DETERIORATION OVER BEARING - LOAD RATING SHEET

D-Meter reading:	X ₁	X ₂	X ₃	X ₄	X ₅	X ₆	X ₇	X ₈	X ₉	X ₁₀	X ₁₁	remaining tw (avg)
Distance from Front of Bearing (in):	+4	+9	+13.5	+16	+19	+23	+26	+29	+32	+35	+37	
4/12/2023	0.42	0.52	0.6875	0.21	0	0.23	0.5	0.51	0.5	0.45	0.61	0.4215909
Notes:												
-Readings were taken from front of bearing since guide angles completely cover web area directly above the bearing.												
-X5 takes into account the two corrosion holes which start at 16" from front of bearing and spans over 3" long area.												
-Previously installed steel angle bolted to the girder web starting at 9" from front of bearing to reinforce end diaphragm connection plate. The steel angle is approximately 4.5" long and D-meter reading assumed to be 0.6875" within area.												
Average Section Loss over D-meter readings	=[(0.6875-0.4216)/0.6875] = 39%											
Remaining Web Area (in ²)	=[(4*0.42)+(5*0.52)+(4.5*0.6875)+(2.5*0.21)+(3*0)+(4*0.23)+(3*0.5)+(3*0.51)+(3*0.45)+(2*0.61)] = 15.92 in ²

As-built Web Area (in ²)	=0.6875*37 = 25.45 in ²											
Overall Web Bearing Area Loss (%)	=[(25.45-15.92)/25.45] = 38%

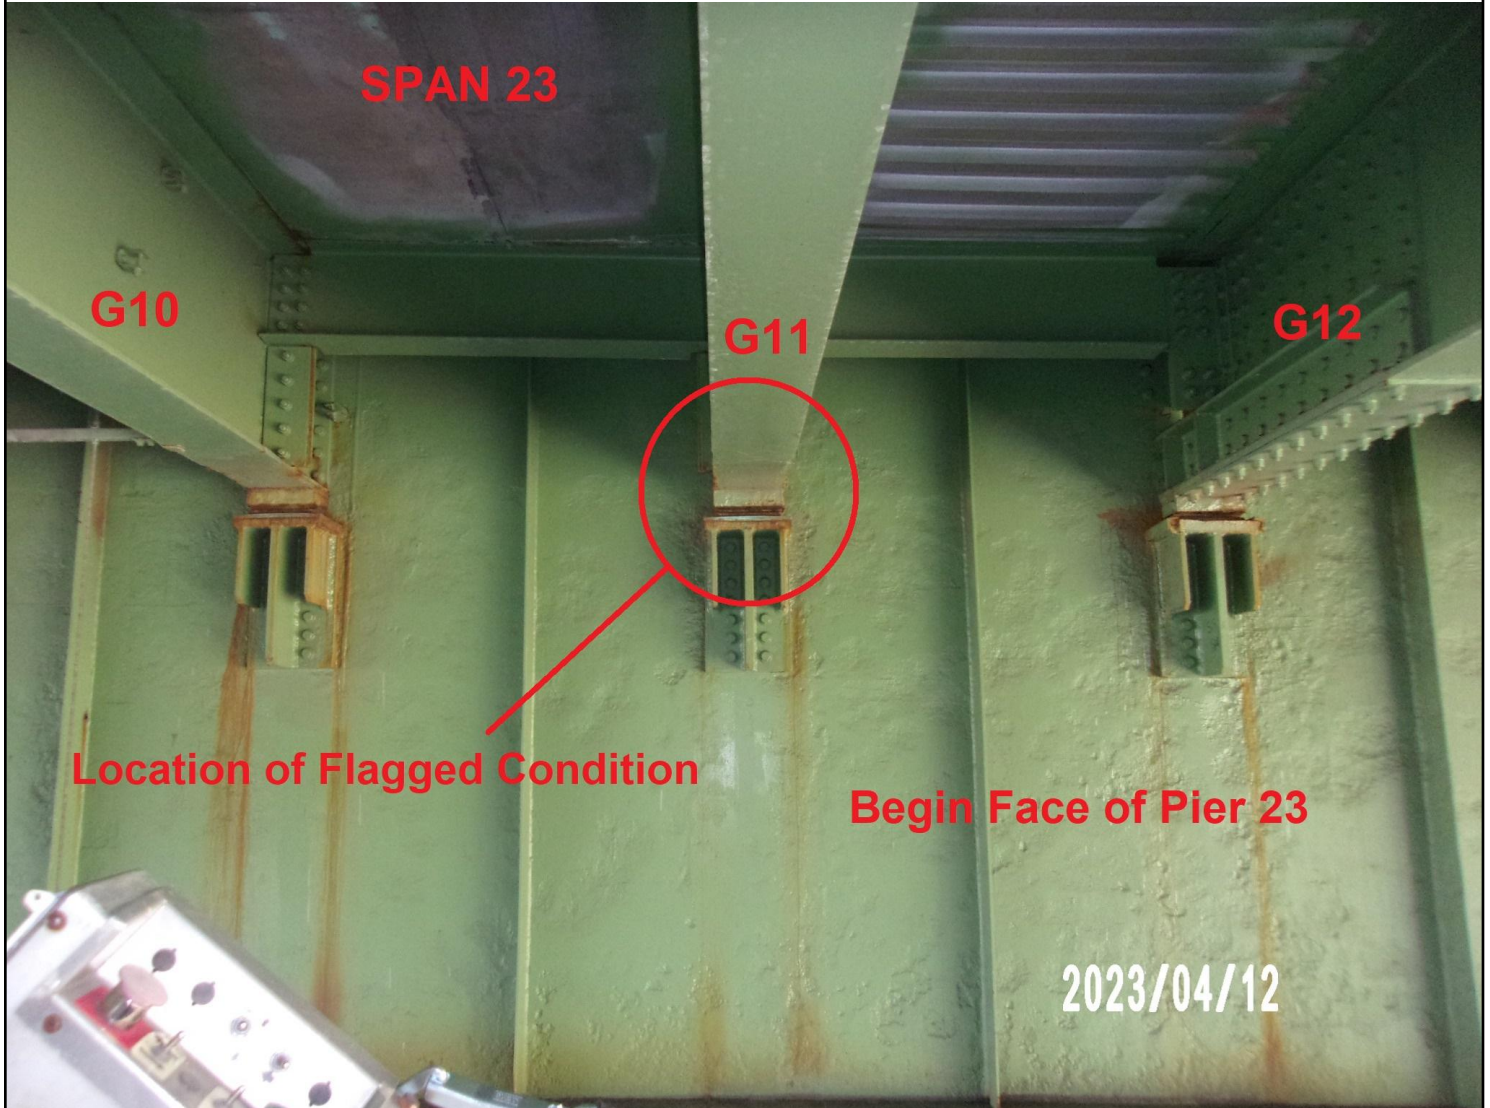
Photo Number: 4

Attachment Description: General view of the flagged location at Girder G11 in Span 23 at Pier 23. Looking End.

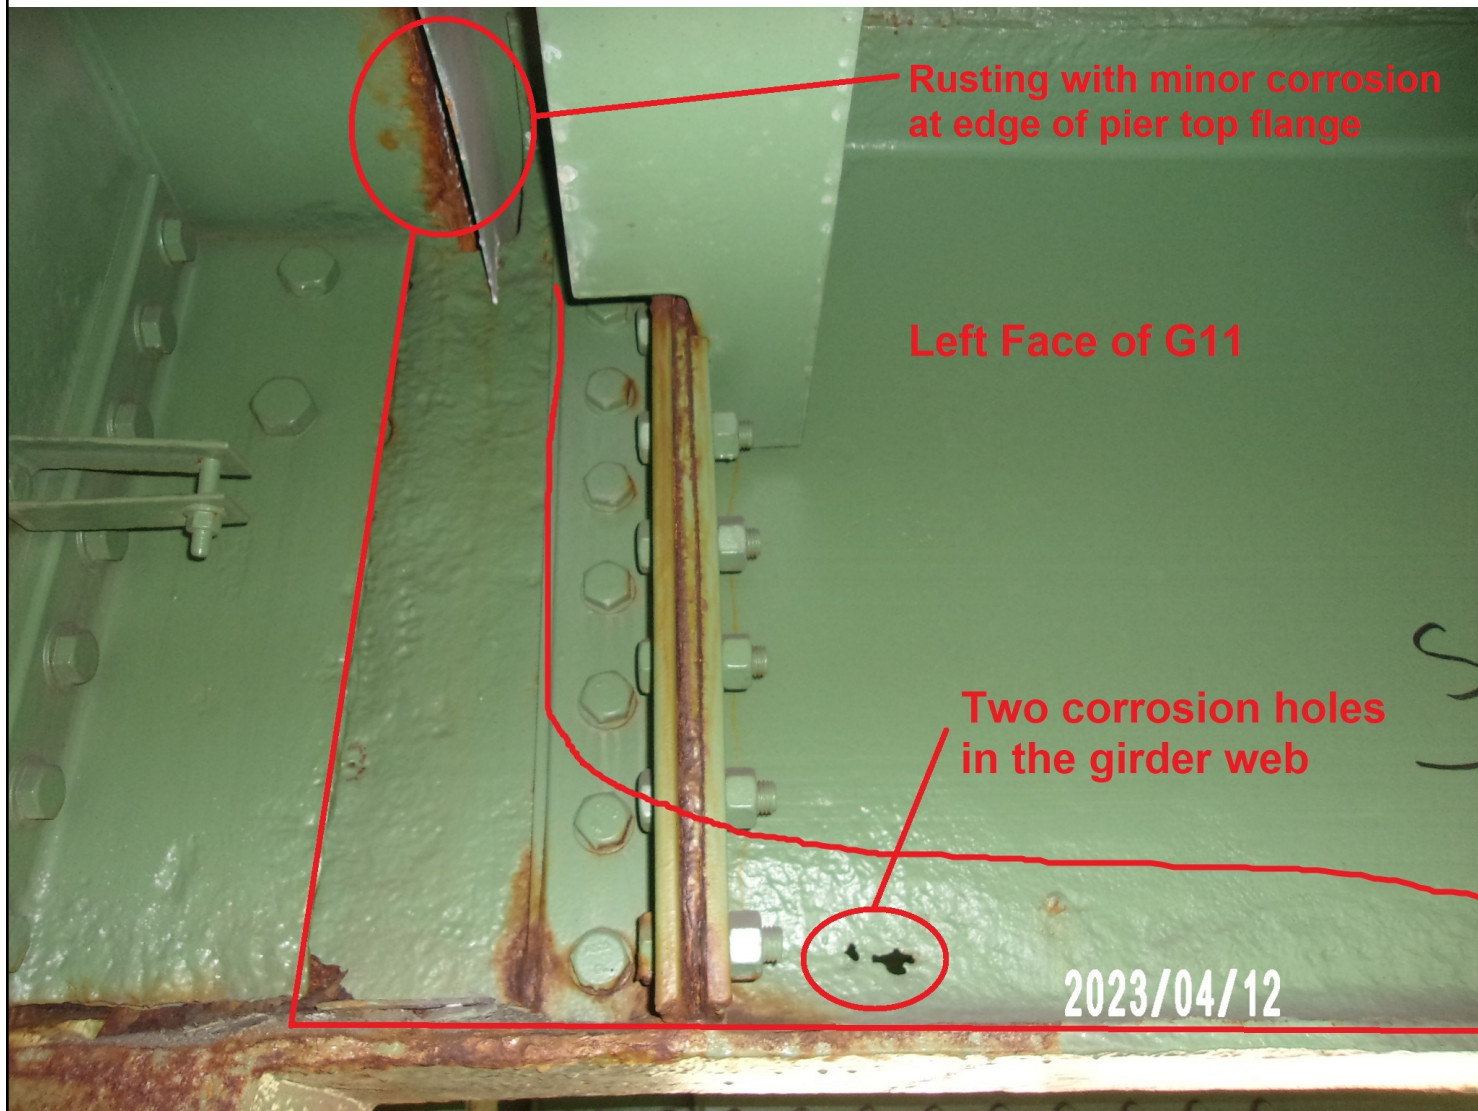
Photo Number: 5

Attachment Description: The left face of Girder G11 in Span 23 at Pier 23. The girder exhibits section loss in the lower web above the bottom flange with remaining web thickness ranging from 0.21" to 0.61" and remaining average web thickness of 0.42" resulting in approximately 39% average section loss. Also, the lower web exhibits two corrosion holes for 1/2" diameter and 1"L x 3/4"H. Looking Right.

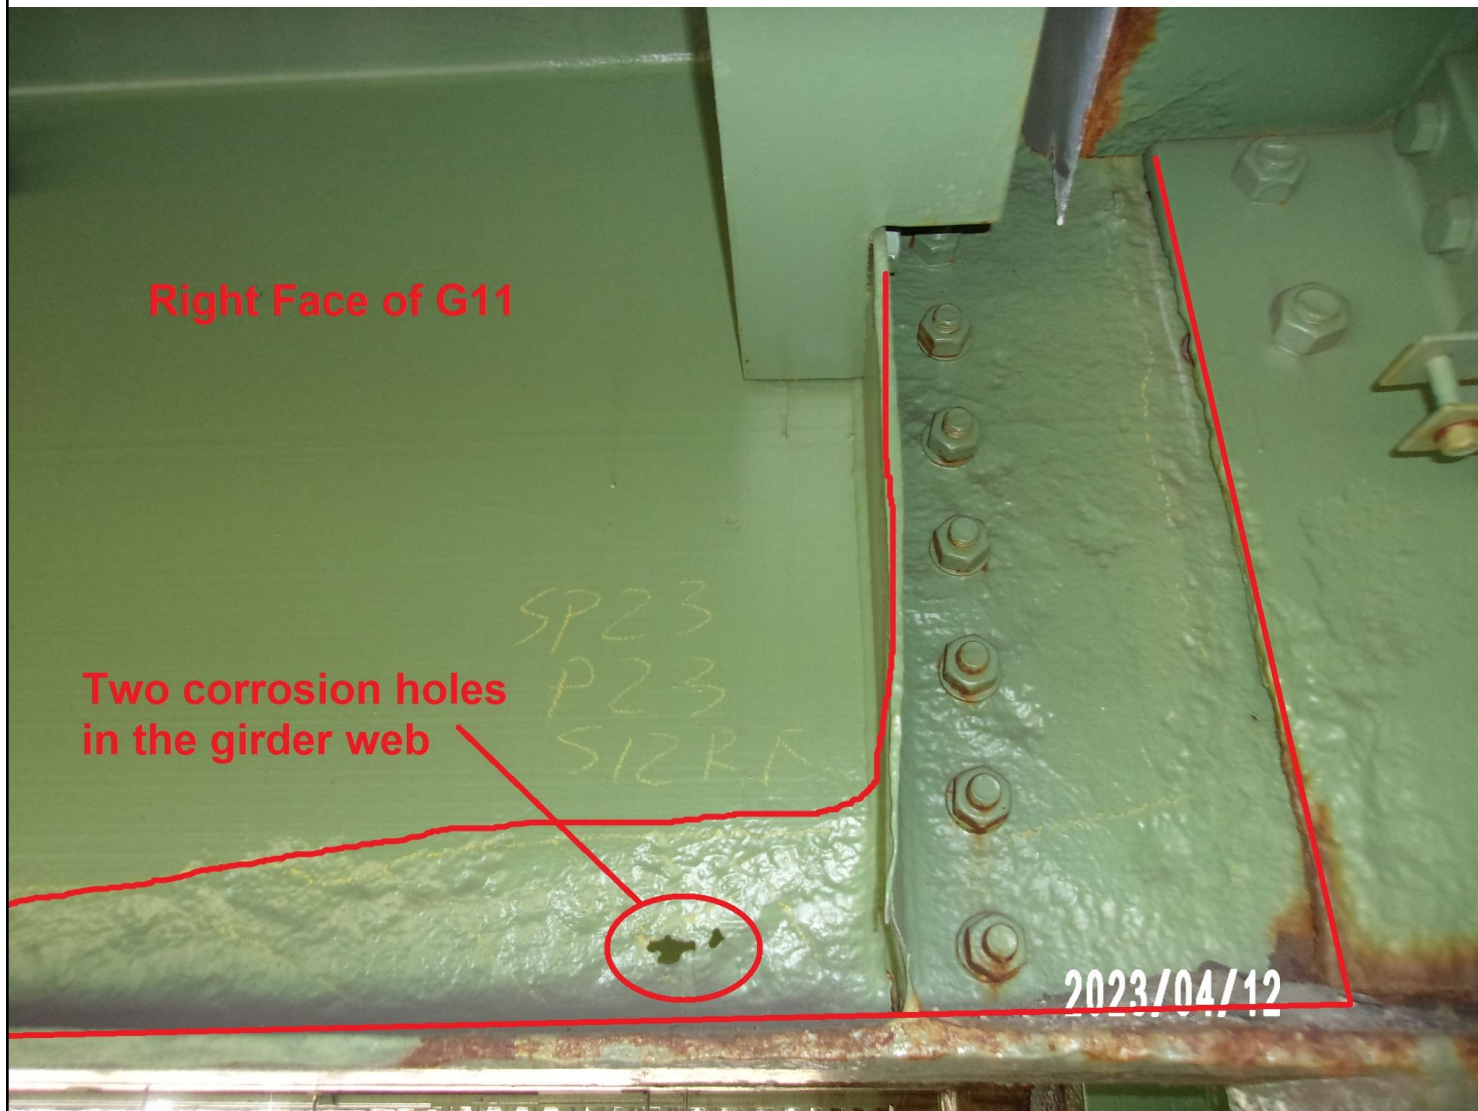
Photo Number: 6

Attachment Description: The right face of Girder G11 in Span 23 at Pier 23. The girder exhibits section loss in the lower web above the bottom flange with remaining web thickness ranging from 0.21" to 0.61" and remaining average web thickness of 0.42" resulting in approximately 39% average section loss. Also, the lower web exhibits two corrosion holes for 1/2" diameter and 1"L x 3/4"H. Looking Left.

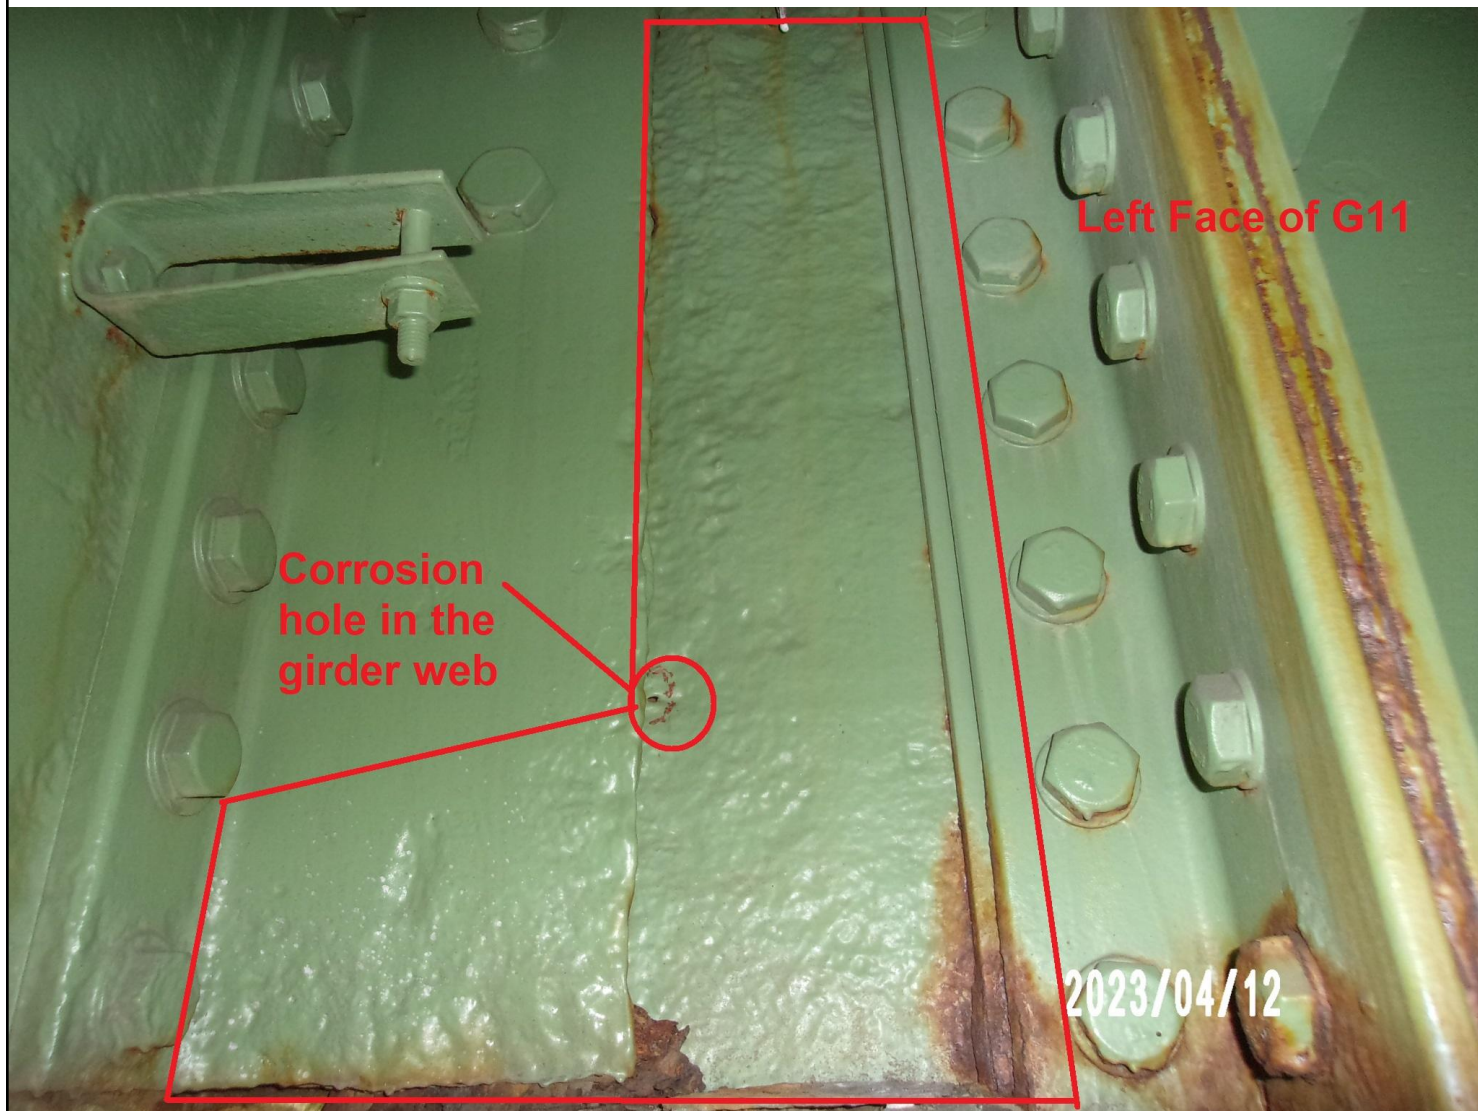
Photo Number: 7

Attachment Description: The left face of Girder G11 in Span 23 at Pier 23. The girder exhibits average localized section loss of 60% for 8" high in front of bearing with remaining web thickness ranging from 0.23" to 0.57" for the remaining web height resulting in approximately 30% overall shear web area loss. Also, the girder web exhibits 1/8" diameter corrosion hole adjacent to the guide angle. Looking Right.

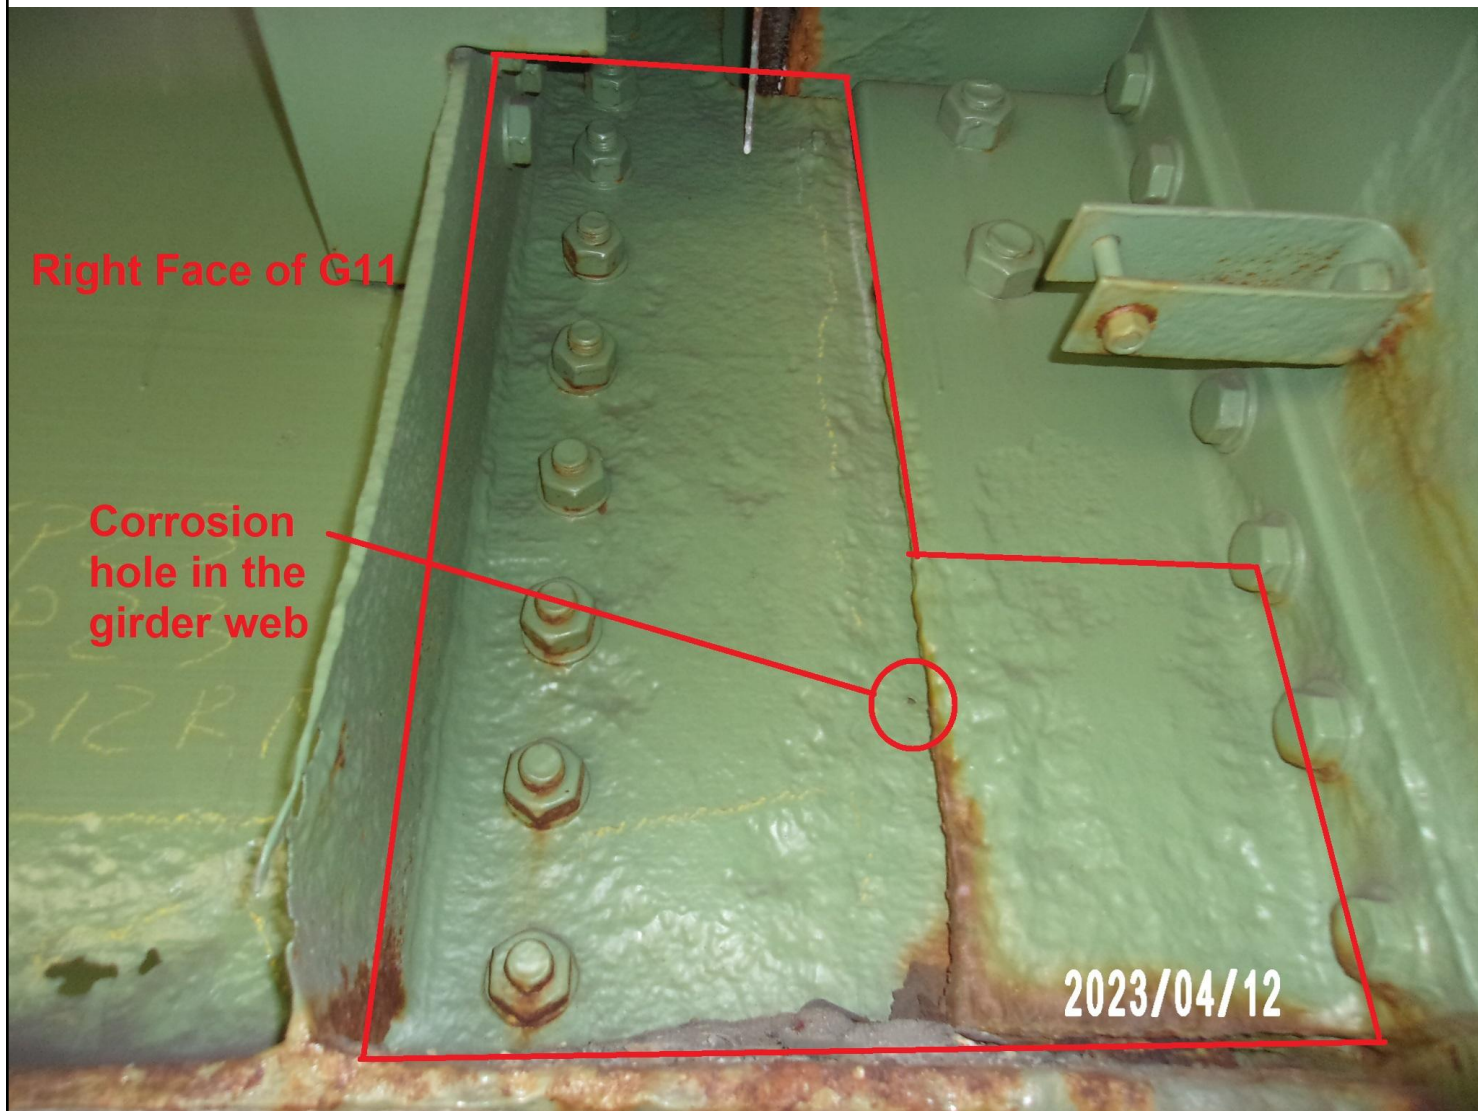
Photo Number: 8

Attachment Description: The right face of Girder G11 in Span 23 at Pier 23. The girder exhibits average localized section loss of 60% for 8" high in front of bearing with remaining web thickness ranging from 0.23" to 0.57" for the remaining web height resulting in approximately 30% overall shear web area loss. Also, the girder web exhibits 1/8" diameter corrosion hole adjacent to the guide angle. Looking Left.

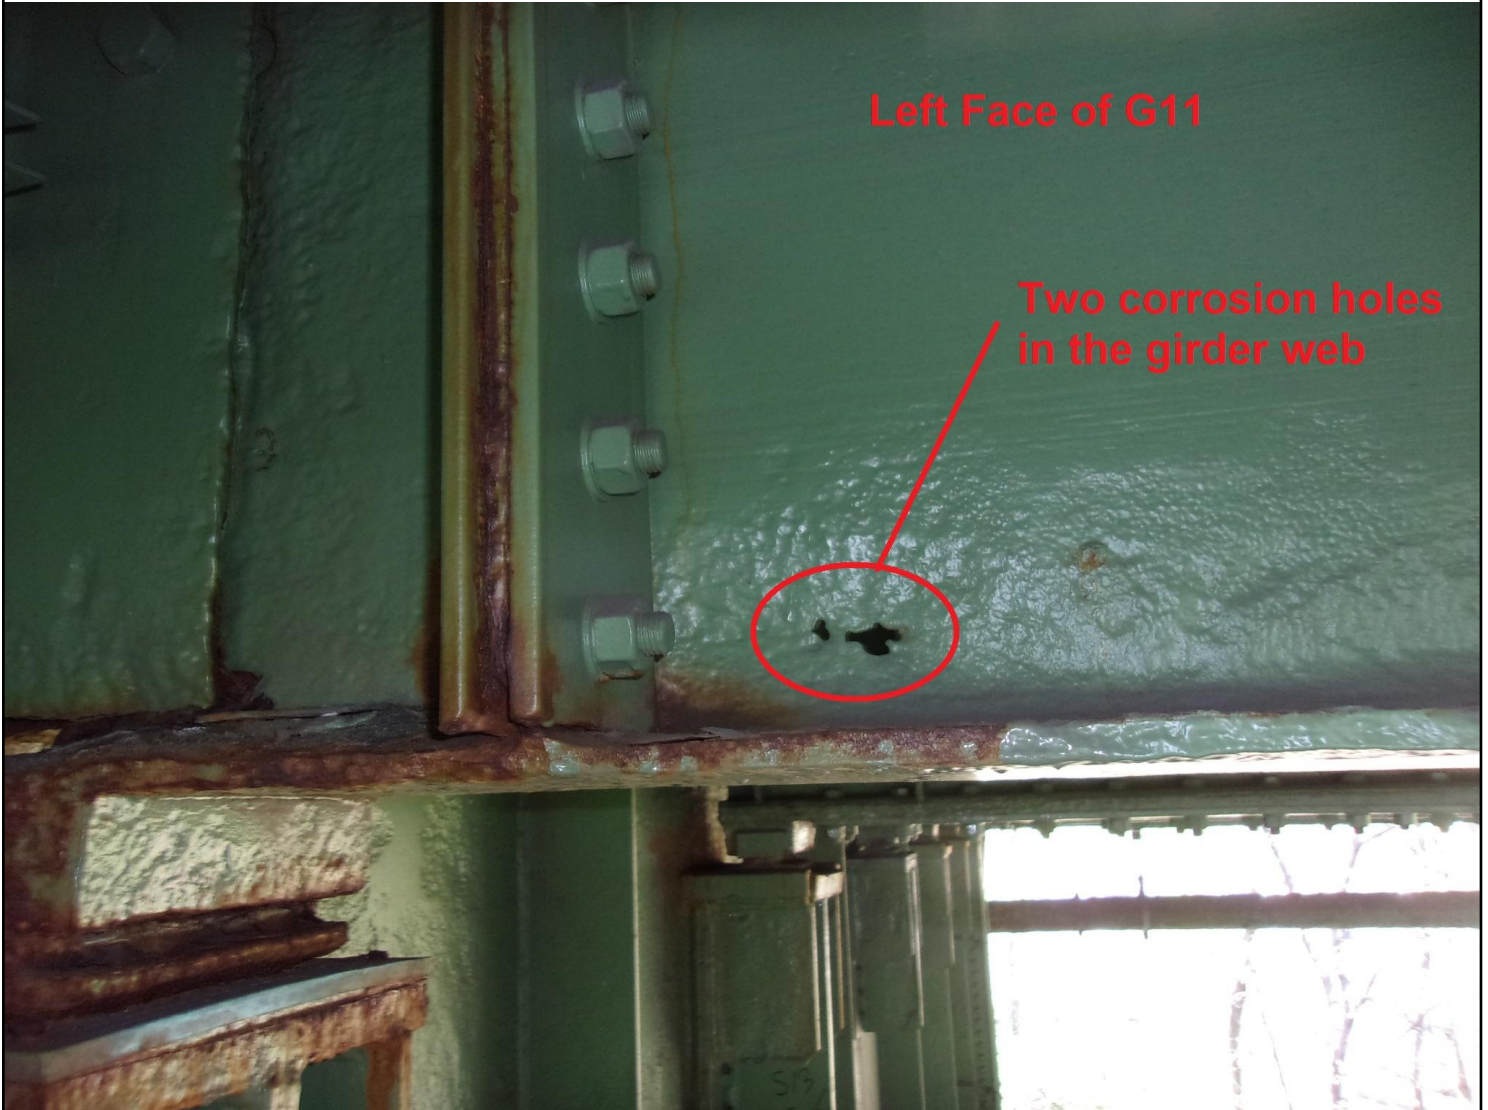
Photo Number: 9

The end of Girder G11 on the Span 23 Side of Pier 23 exhibits section loss in the lower web above the bottom flange in front of the bearing (begin side of bearing) over a 40"L x 5"H area with remaining web thickness ranging from 0.21" to 0.6875" and remaining average web thickness of 0.42" resulting in approximately 39% average section loss over this web bearing area (Photo #5 and #6). The localized web area adjacent to the front side of the bearing exhibits average localized section loss of 60% for 8" high. The full height of the girder web exhibits section loss along the guide angle with remaining web thickness ranging from 0.23" to 0.57" resulting in approximately 30% overall shear web area loss. (Photos #7 and #8) In addition, the girder web exhibits two corrosion holes in the lower web approximately 16" from the front side of the bearing for 1/2" diameter and 1"L x 3/4"H approximately 2" above the bottom flange and one 1/8" diameter corrosion hole approximately 7" above the bottom flange adjacent to the guide angle (Photos #9 and #10).

Attachment Description: The left face of Girder G11 in Span 23 at Pier 23. Close up view of the two corrosion holes for 1/2" diameter and 1"L x 3/4"H approximately 16" from the front side of the bearing and 2" above the bottom flange. Looking Right.

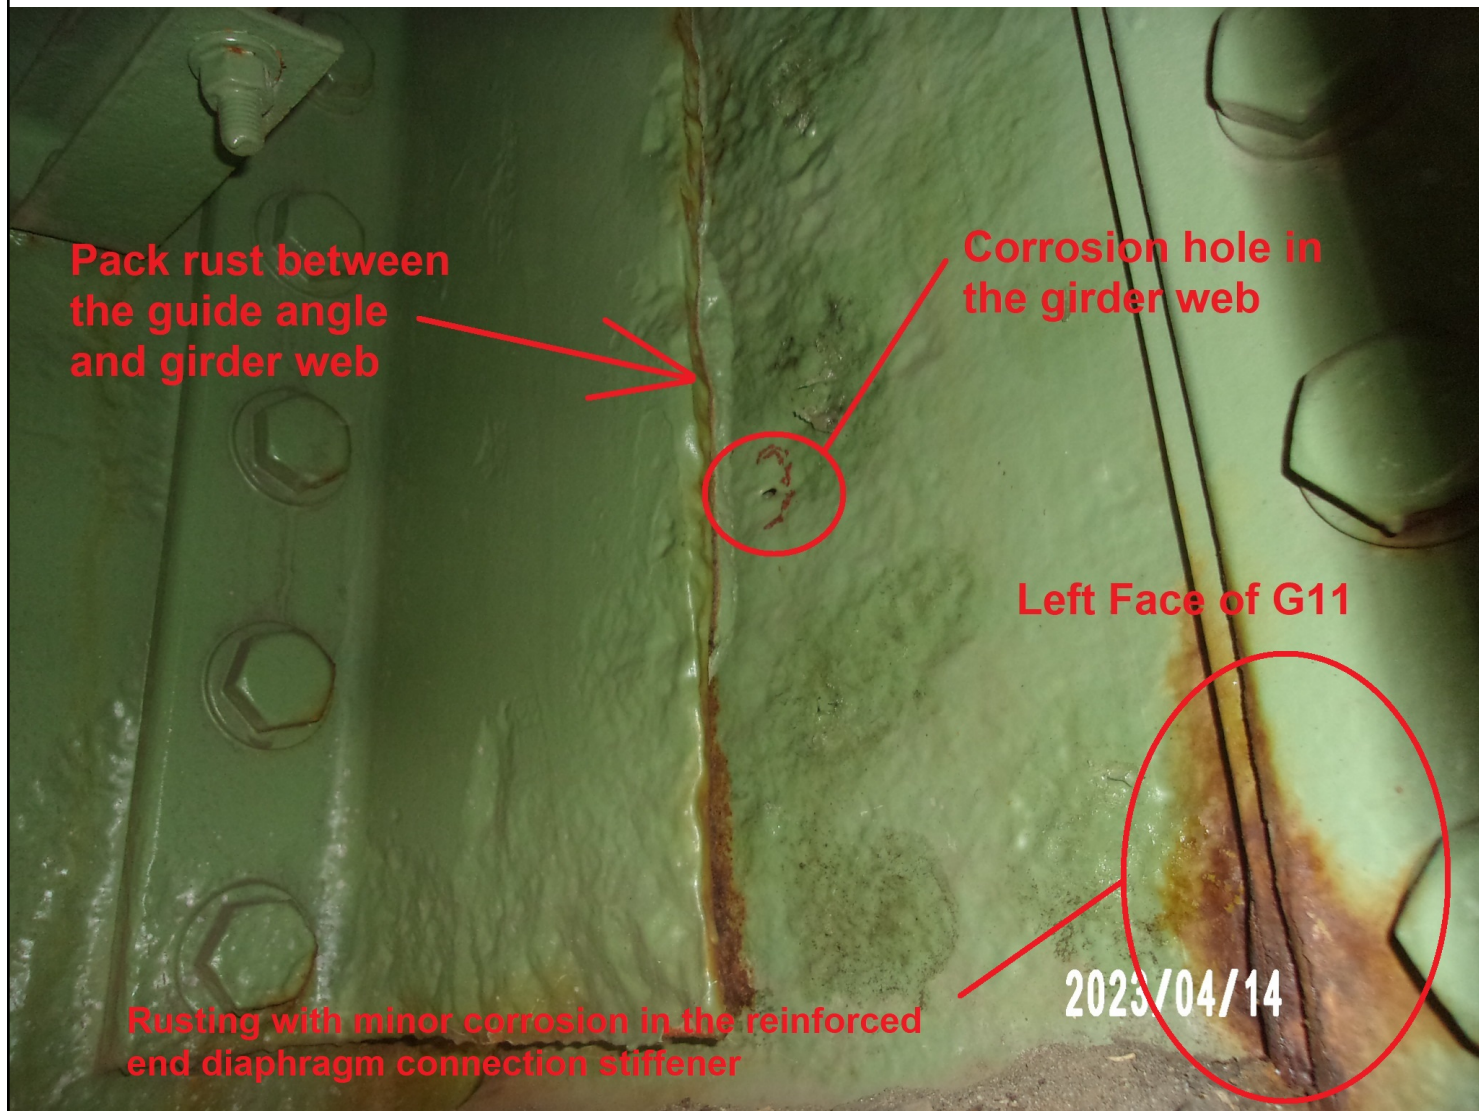
Photo Number: 10

The right side end diaphragm connection plate to Girder G11 exhibits 50% section loss for the bottom 12" of the stiffener with one corrosion hole for 4"H x 1/2"W at the bottom of the stiffener. The left side end diaphragm connection plate has previously installed steel reinforcement angles which are in good condition. The bottom flange of Girder G11 exhibits 1/16" deep section loss for 24"L x 2"W at the edge of the right side. The guide angles exhibit 1/16" deep section loss for the full width of the angles for the bottom 3" at the left angle and bottom 12" at the right angle with up to 1" thick pack rust between the guide angle and girder web for the full height of the angles at both faces of the girder. (Photo #10) (refer to Yellow Flag condition sketches #2 and #3 for more details)

Attachment Description: The left face of Girder G11 in Span 23 at Pier 23. Close up view of the one corrosion hole for 1/8" diameter adjacent to the guide angle approximately 7" above the bottom flange. Also, the guide angle exhibits 1" pack rust between the angle and girder web. Looking End and Right.
